Blake

Waterbody + Tributary 100ft Buffer

High-Resolution Land Cover Summary

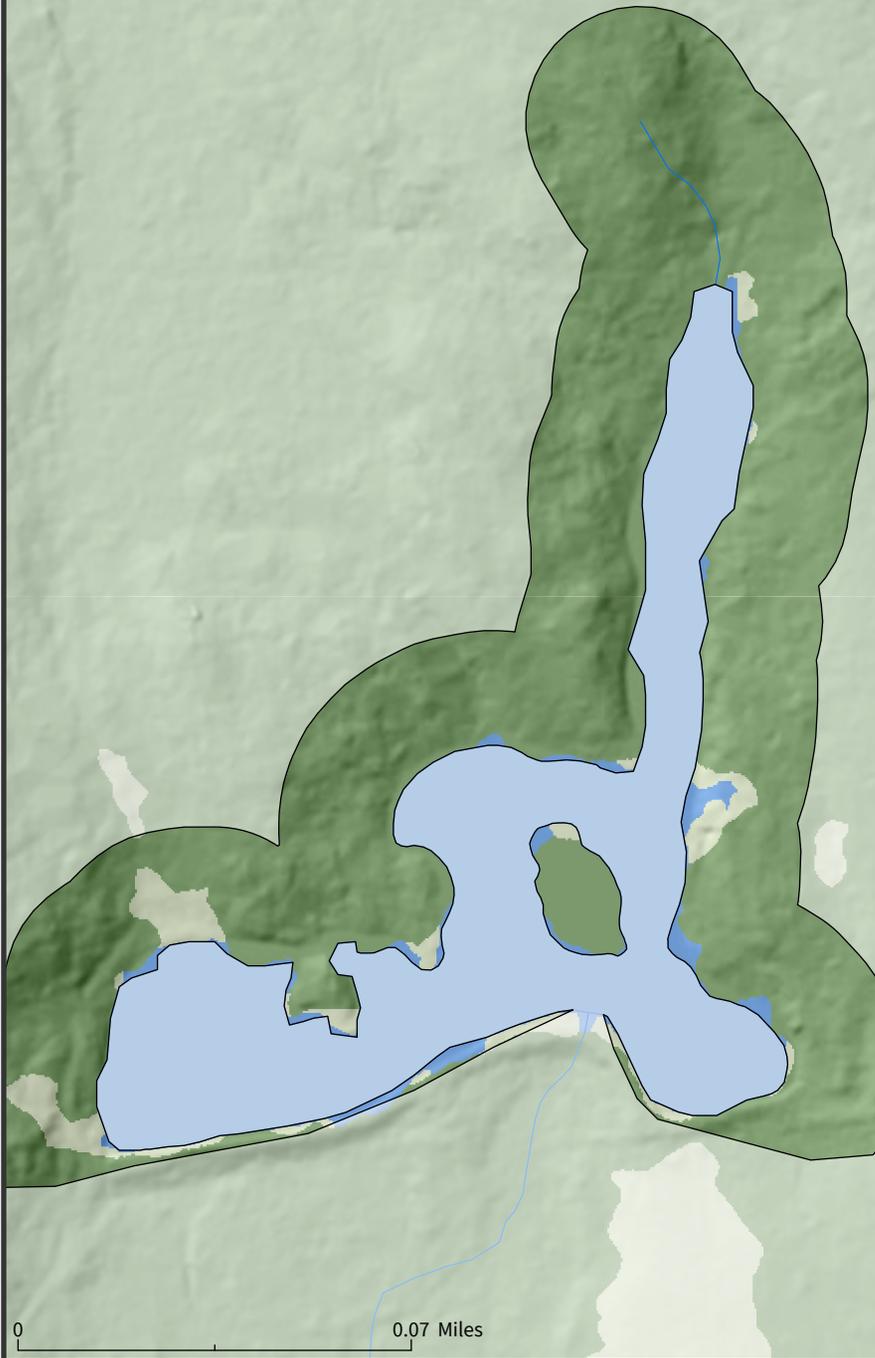
6 acres
(Base Land Cover Shown)

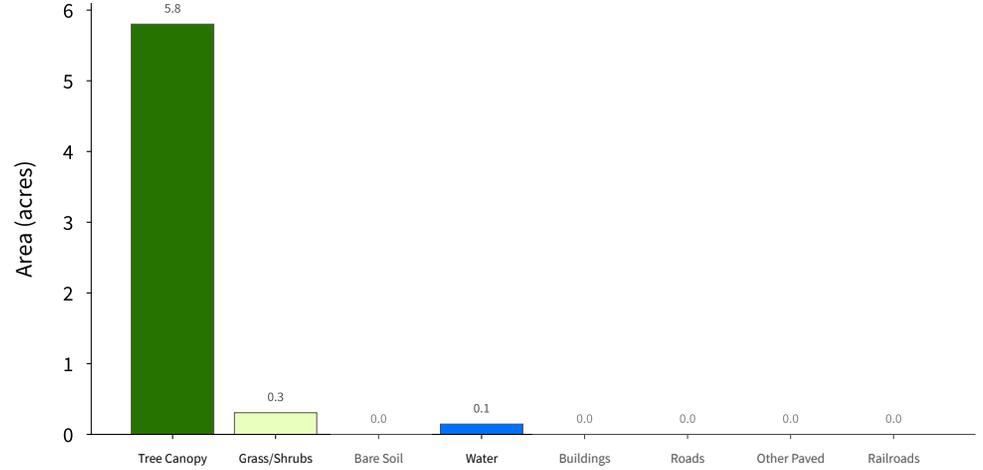
Base Land Cover (Top-Down*)

*Top-Down: A traditional land cover mapping approach - land cover is mapped as the uppermost land cover class.

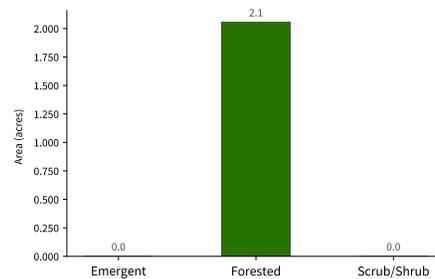
Wetlands (2.06 acres - 34.3 % of total)

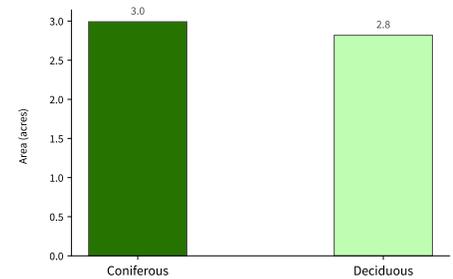
Tree Canopy (5.81 acres - 96.9 % of total)

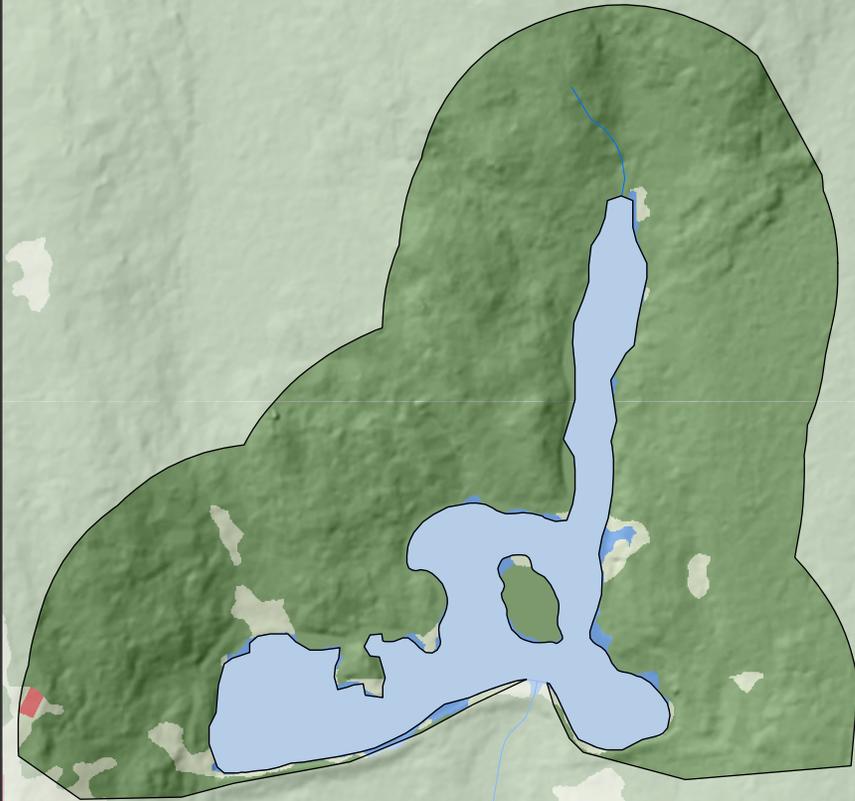
Waterbody 250ft Buffer

14 acres
(Base Land Cover Shown)

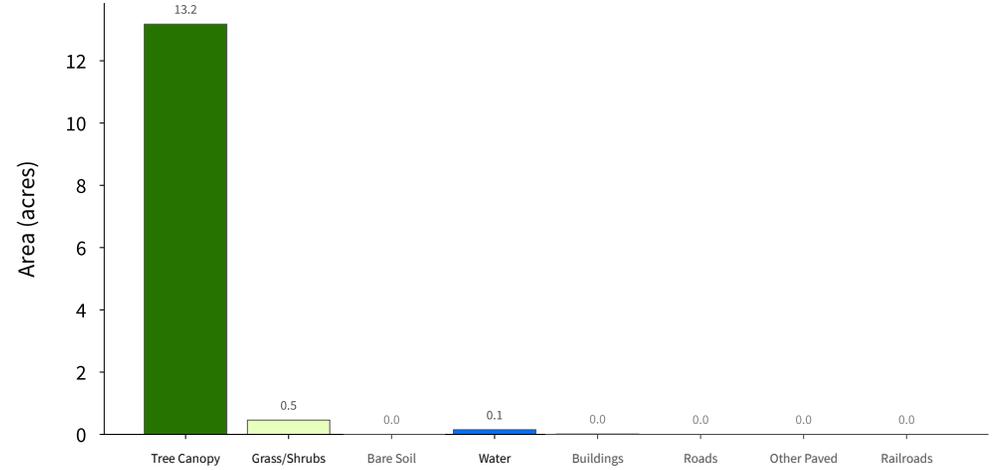
High-Resolution Land Cover Summary

Base Land Cover (Top-Down*)

*Top-Down: A traditional land cover mapping approach - land cover is mapped as the uppermost land cover class.
 **Bottom-Up: A new land cover mapping approach - land cover is mapped as the lowermost land cover class. This approach results in improved mapping of features overlapped/observed by other features.
 See UWM SAL High-Resolution Land Cover 2025 Report for more detail.

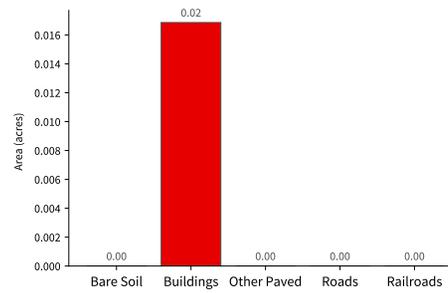
Impervious Surfaces (0.02 acres - 0.1 % of total) (Bottom-Up**)

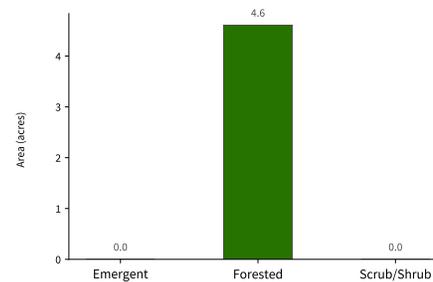
Wetlands (4.61 acres - 32.9 % of total)

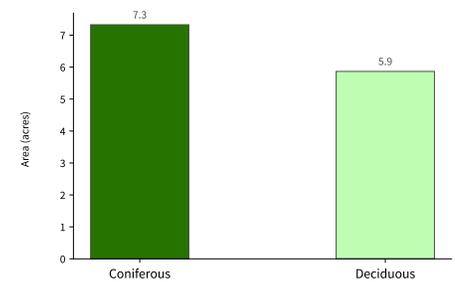
Tree Canopy (13.19 acres - 94.2 % of total)

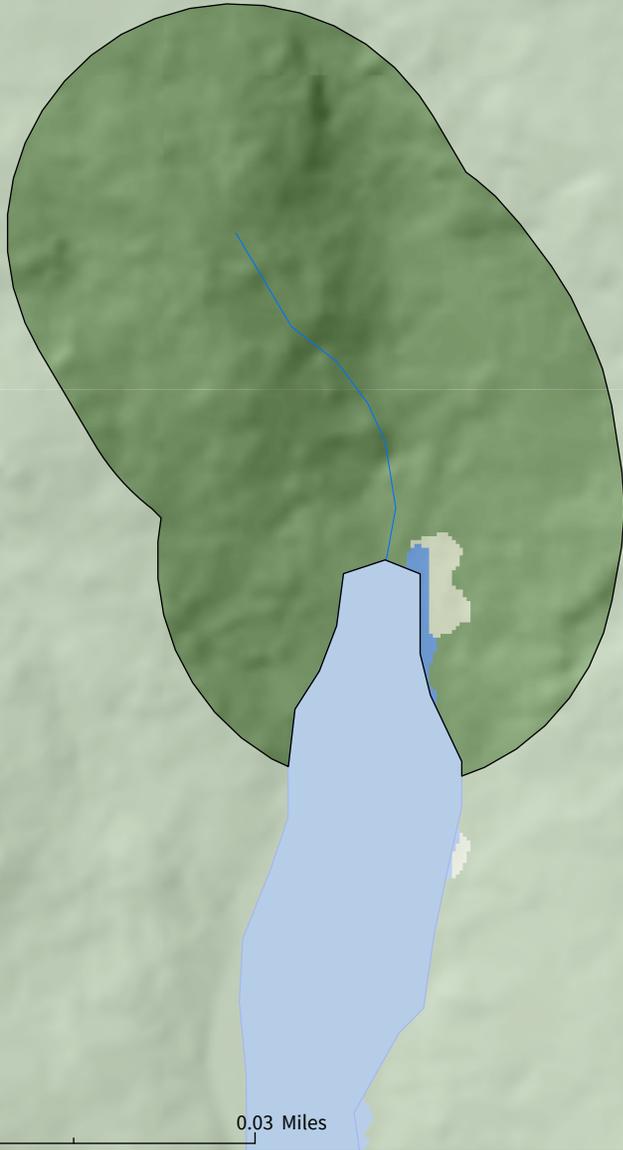
Tributary 100ft Buffer

1 acres
(Base Land Cover Shown)

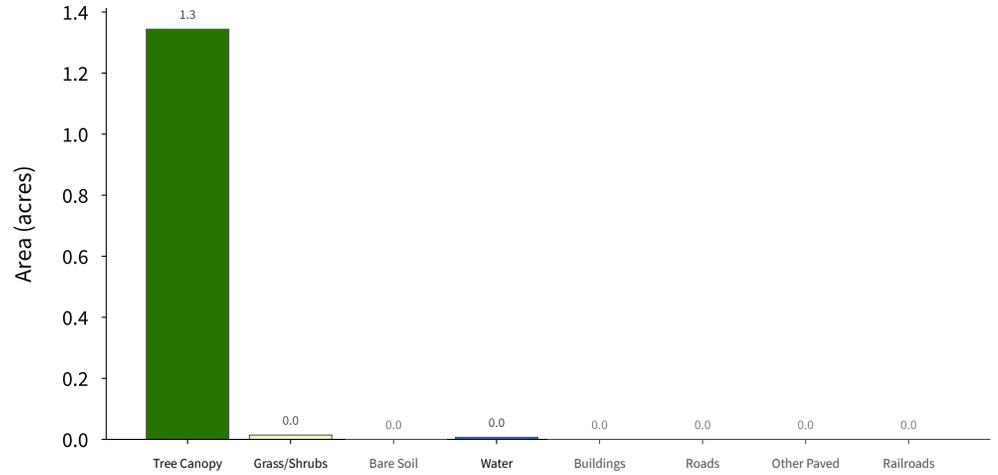
High-Resolution Land Cover Summary

Base Land Cover (Top-Down*)

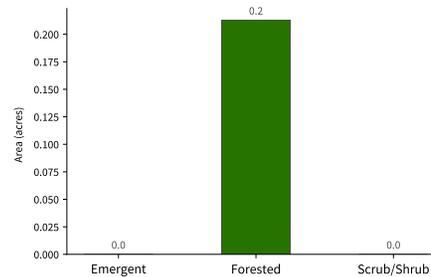
Wetlands (0.21 acres - 21.3% of total)

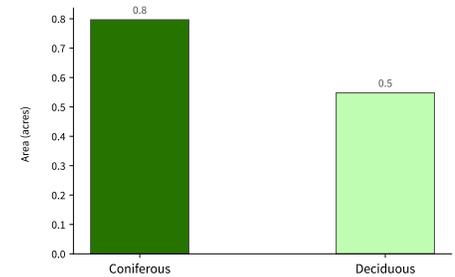
Tree Canopy (1.34 acres - 134.5% of total)

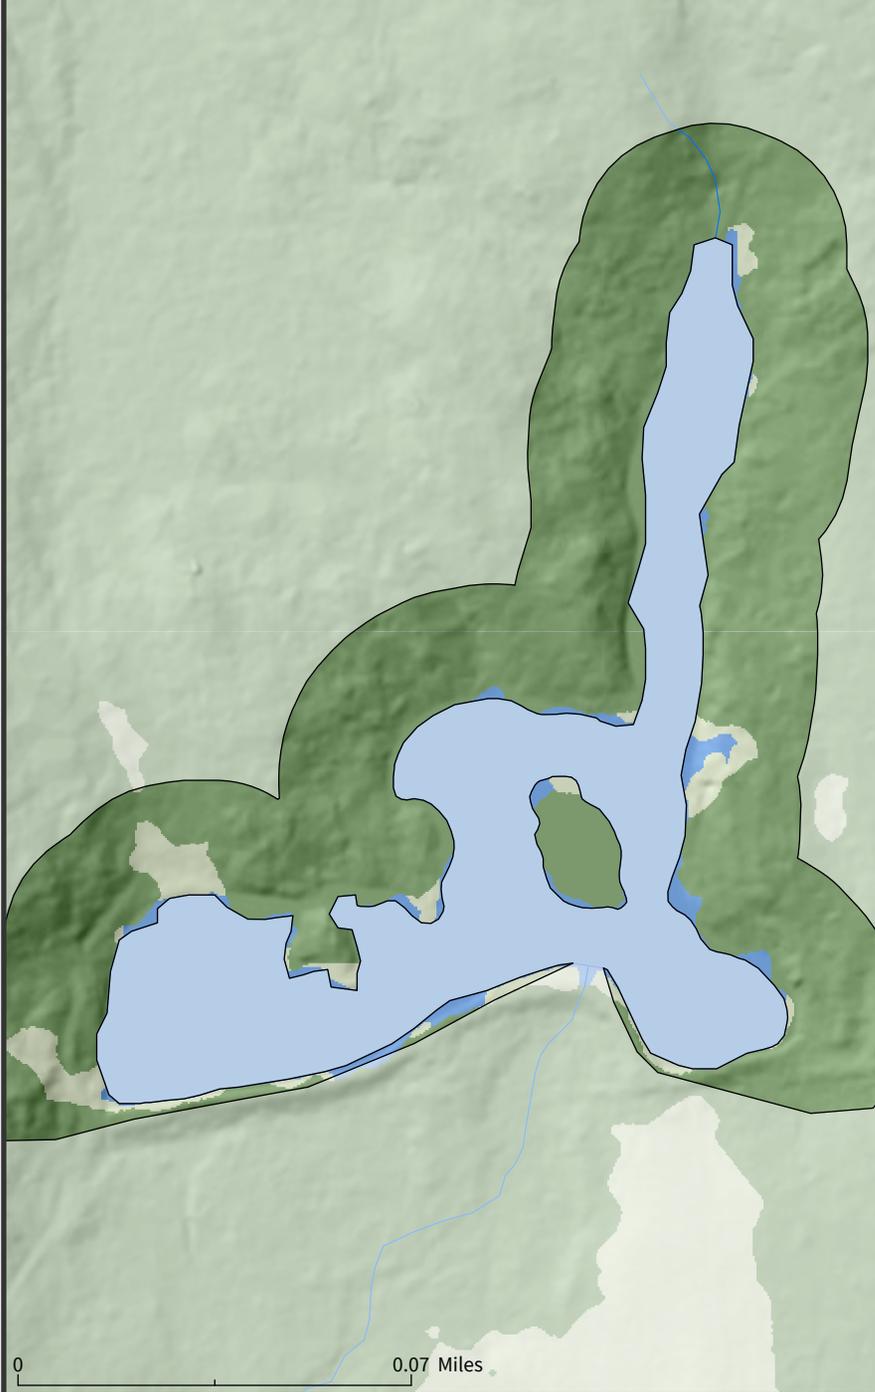
Waterbody 100ft Buffer

6 acres
(Base Land Cover Shown)

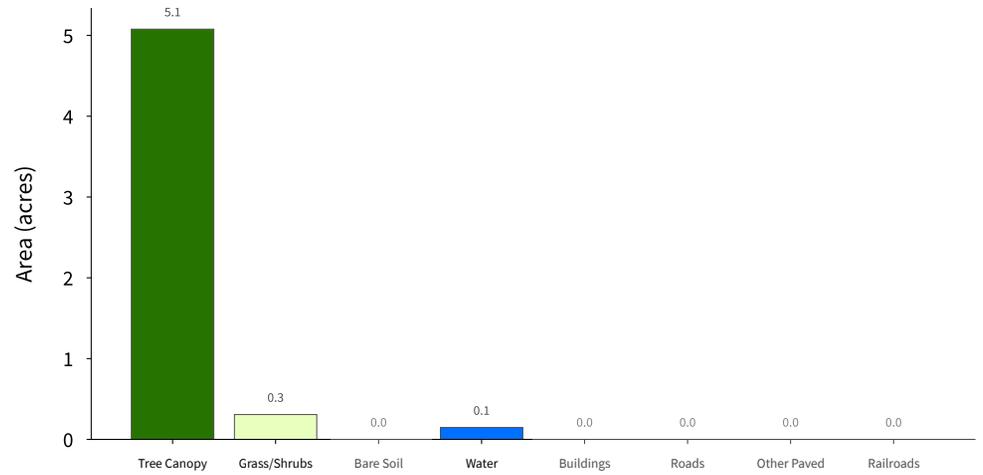
High-Resolution Land Cover Summary

Base Land Cover (Top-Down*)

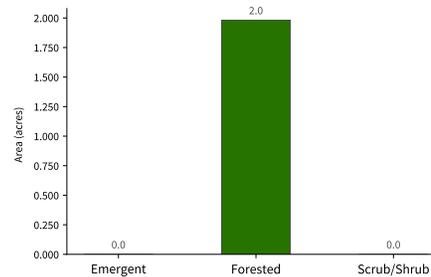
Wetlands (1.98 acres - 33 % of total)

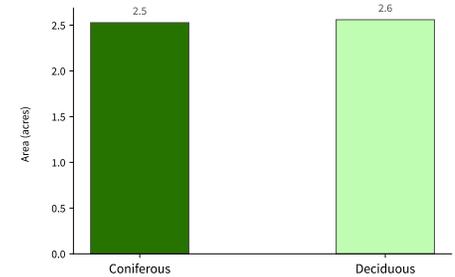
Tree Canopy (5.09 acres - 84.8 % of total)

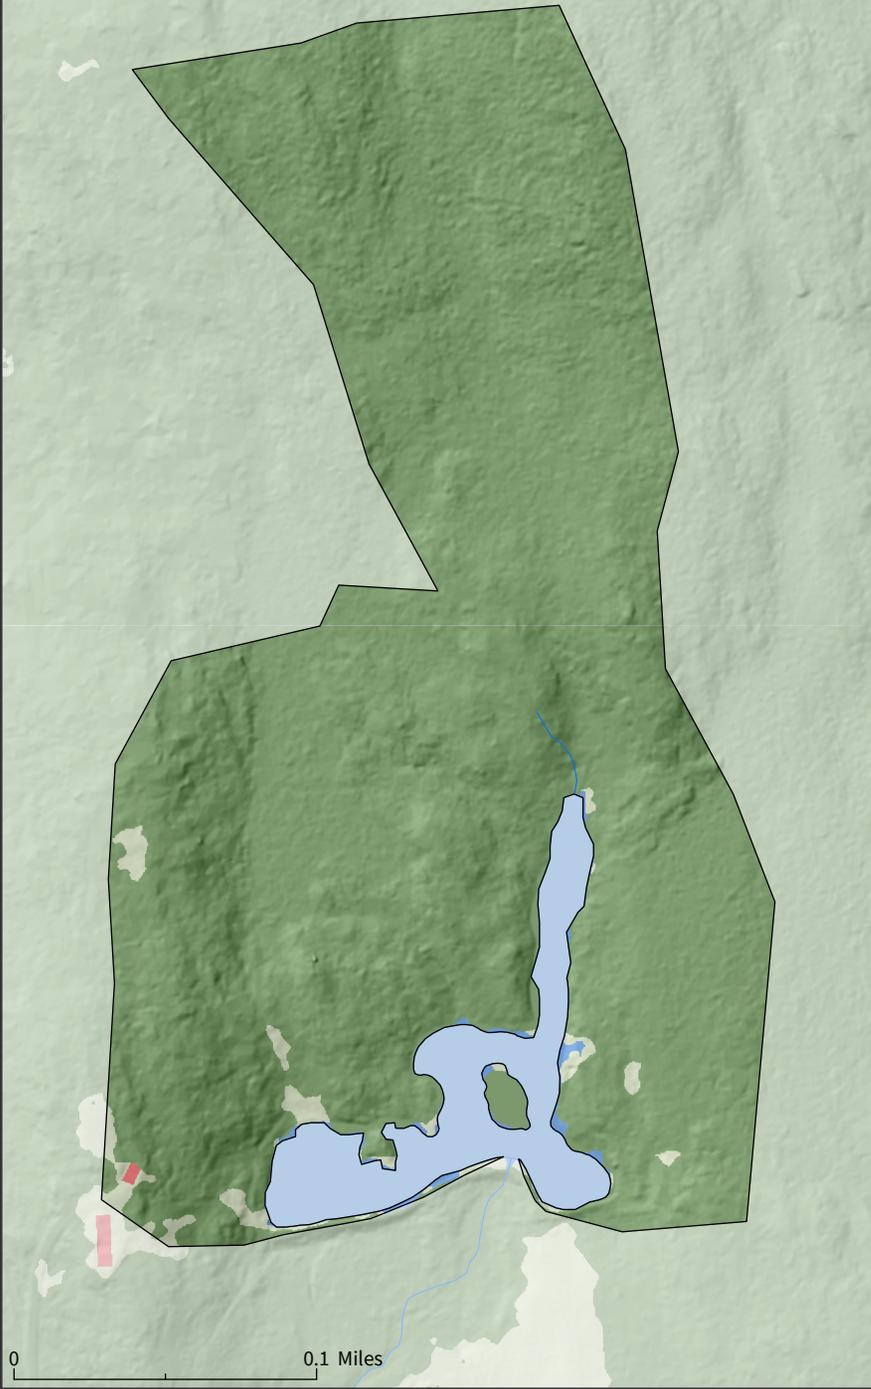
Watershed

37 acres
(Base Land Cover Shown)

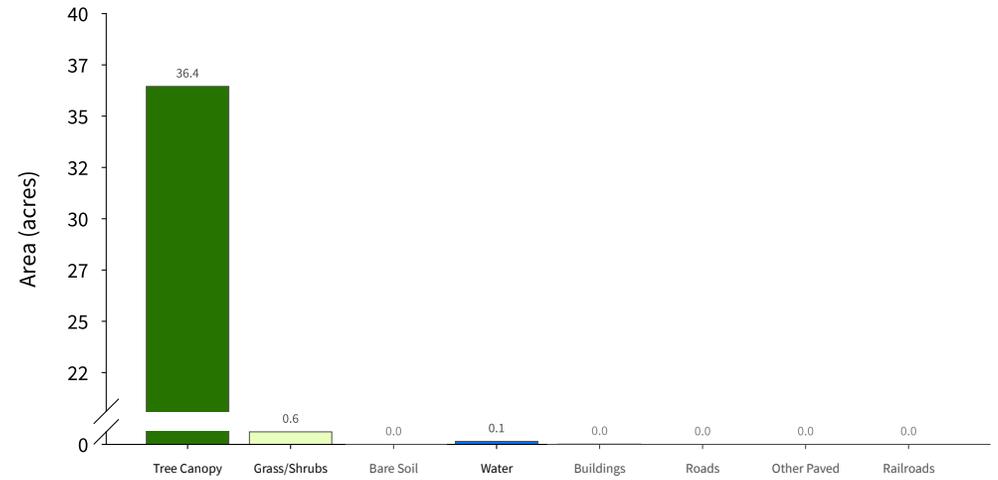
High-Resolution Land Cover Summary

Base Land Cover (Top-Down*)

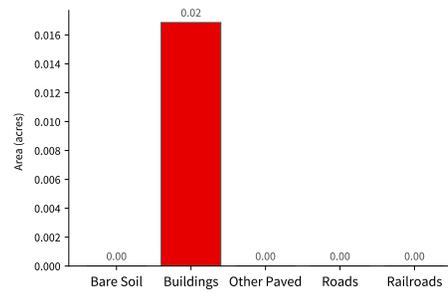
Impervious Surfaces (0.02 acres - 0% of total) (Bottom-Up**)

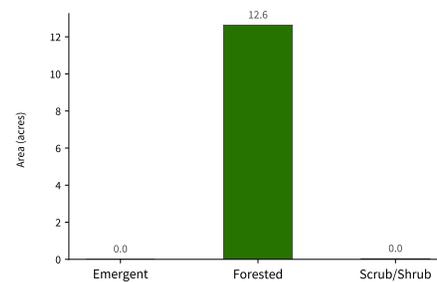
Wetlands (12.65 acres - 34.2% of total)

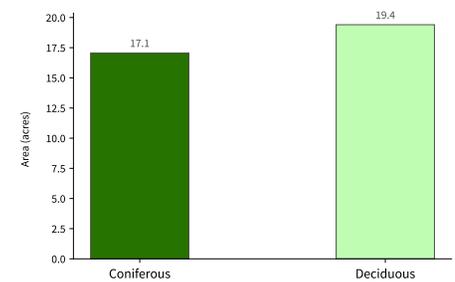
Tree Canopy (36.46 acres - 98.5% of total)
